911 Home Inspection Services, LLC

Home Inspection Report

**205 N. Main Street
Anywhere, IL 66222**

Inspected on February 8, 2013

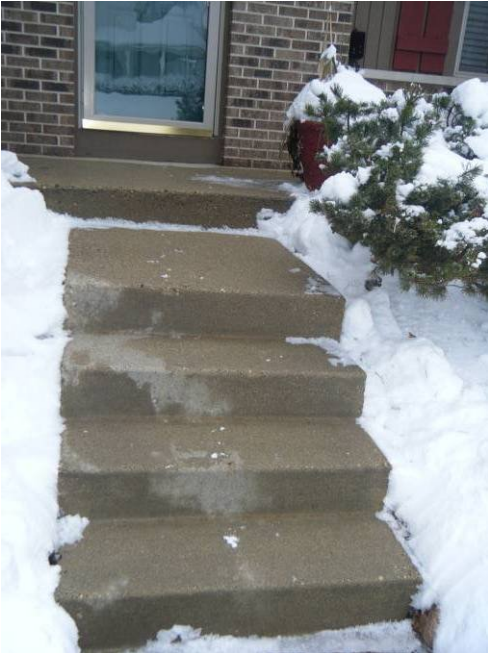
2 Should have a railing

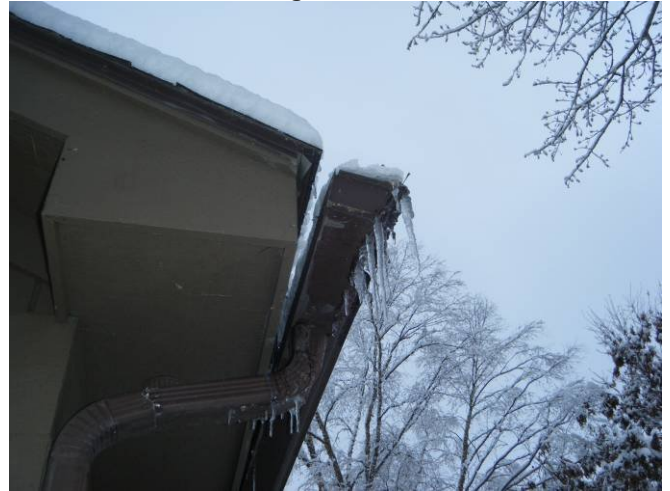
1. The roof was snow covered and not visible. If concerned, have the roof evaluated after the snow melts.
2. The gutter fell and bent on the south side from the weight of being filled with snow/ice.
3. The gutter in the NE corner is loose.
4. All gutter supports should be checked.
5. Ensure all downspouts have extensions that direct rainwater 4-6' from the foundation.

5 Loose gutter in NW corner

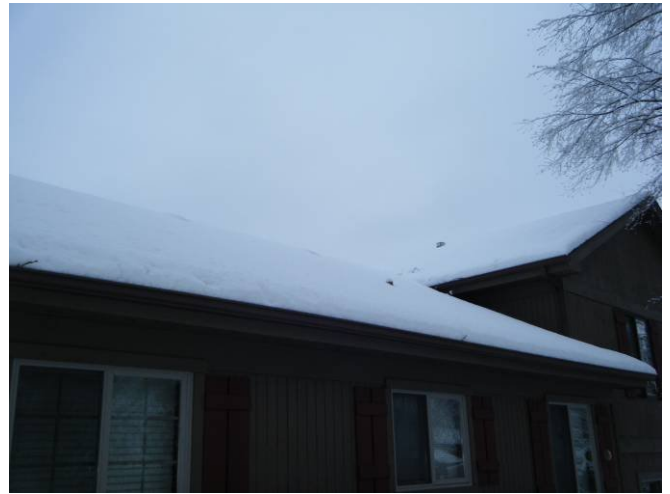
11 Roof snow covered

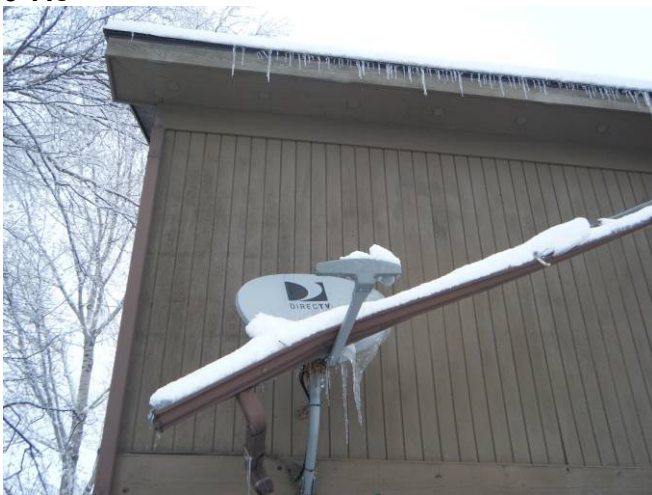
9 Gutter fell

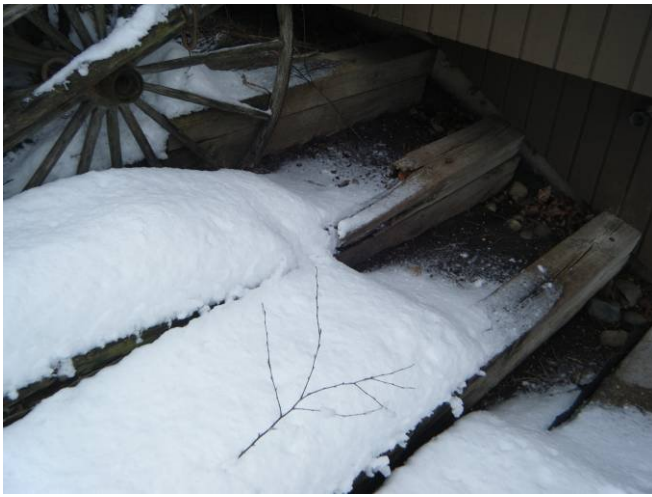
13 Three step retaining wall rotted and leaning

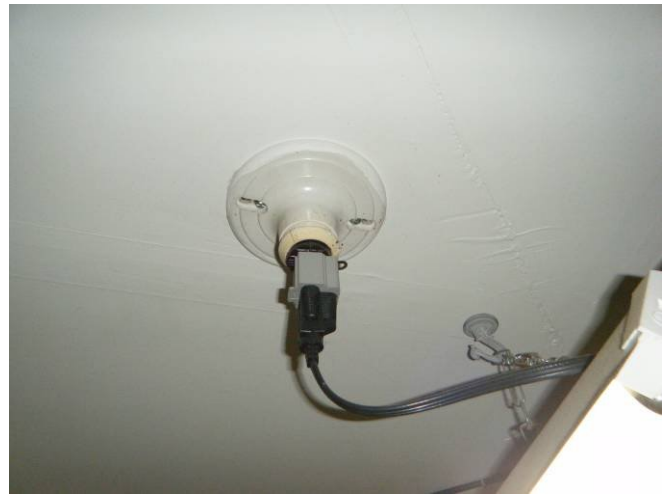
1. The outlet below the electric panel should be upgraded to provide GFCI protection since the other outlet does.
2. The light fixture adapter to make it an outlet is not recommended. A second adapter is bypassing the ground prong of the light fixture.
3. Ask the homeowner what the three green wires around the ceiling beam are for. If these are electrical they are not installed properly and should be evaluated and corrected by an electrician. The holes should be sealed as the drywall is the fire separation between the garage and living space above.

16 Garage - Adapters not recommended

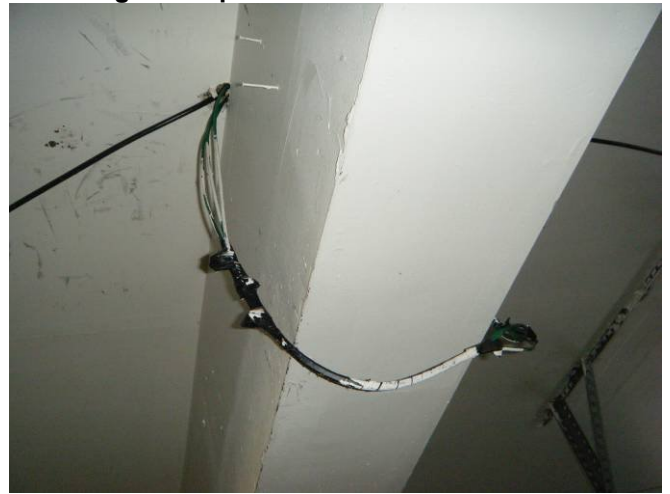
17 Garage - Ask homeowner what these are for. Correct if electrical

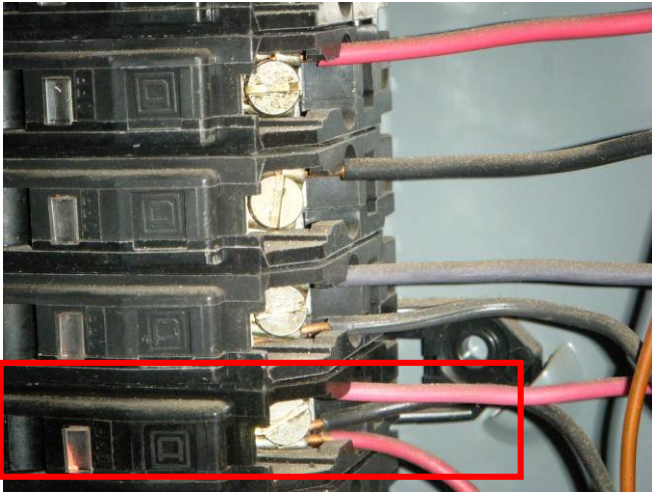
1. In the main panel one breaker is triple tapped - three wires to one breaker. This is a fire hazard and should be corrected by a licensed electrician.

19 Triple tap is a fire hazard

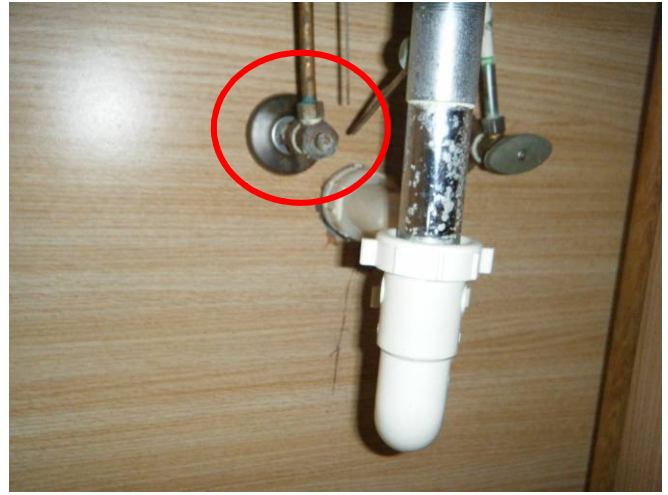
1. The hot water shut-off valve under the sink has a broken handle stem and should be replaced.

22 Hot water valve stem broken for hot water in powder room

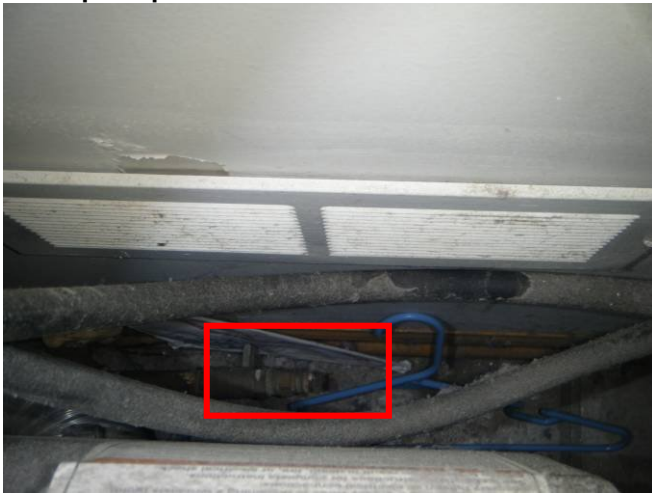
1. Lint is highly flammable. Clean the dryer vent when you first move in and at least annually thereafter.
2. The gas line should be capped to prevent a gas leak should the valve accidentally open or begin to leak.
3. If a utility sink is installed ensure the 220 volt dryer outlet is GFCI protected.

20 Cap unused gas line behind dryer

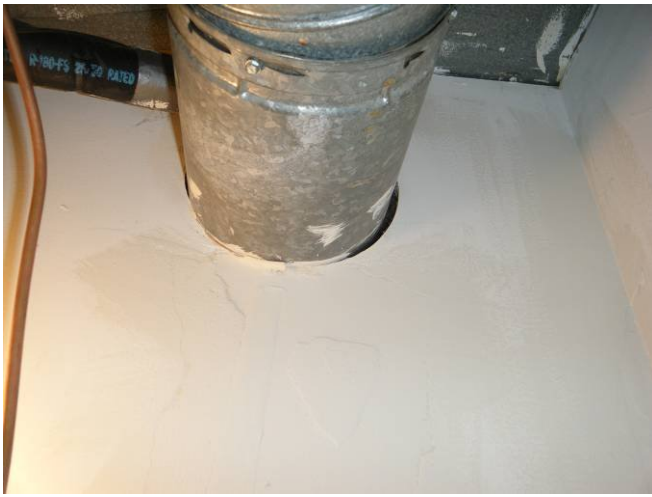
5. The flue pipe should have 1-2" of clearance between itself and anything combustible. It is in direct contact with the drywall.
6. The air conditioner has a faded label that is hard to read. It may be a 1995. The AC was not able to be tested due to the outdoor air temperature being below 65°F. Operating an air conditioner below this temperature for an extended period of time can damage the unit.

24 Flue in direct contact with drywall. Must have 1-2" of clearance

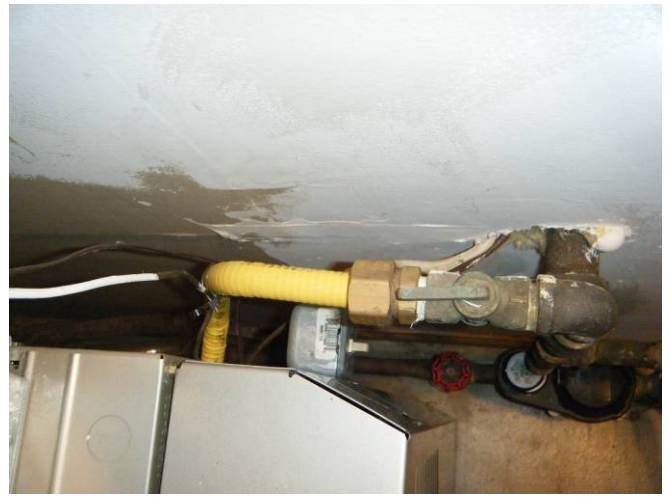
4. There is a flexible gas line for the furnace. While functional, this may not meet local code. Typically rigid pipe is required. Contact the local building department if this is a concern.

26 Flex gas line on furnace

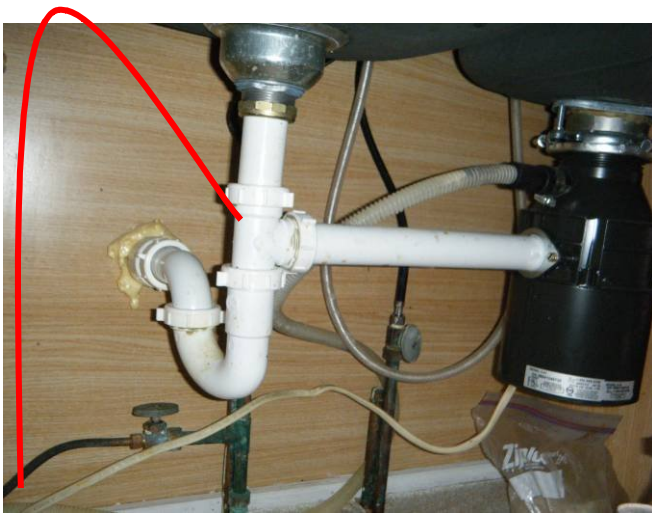
29 Sink drain doesn't arc and is connected to disposal

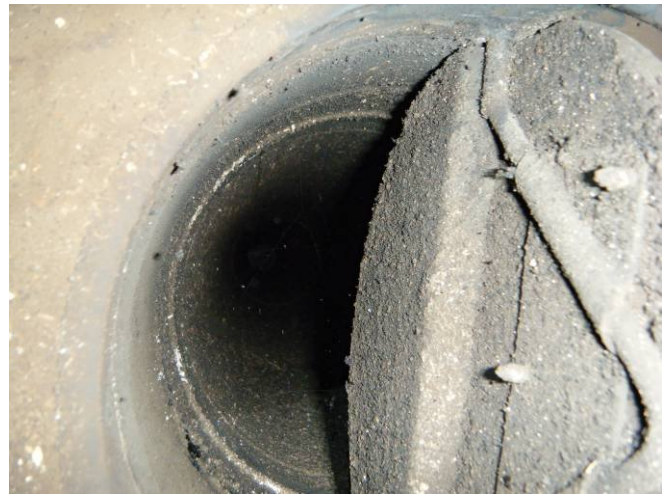
1. The fireplace flue has build-up and is due to be cleaned by a certified chimney sweep.
2. A wood burning grate is recommended. The current one is for gas logs.

33 Fireplace flue - Time to be cleaned

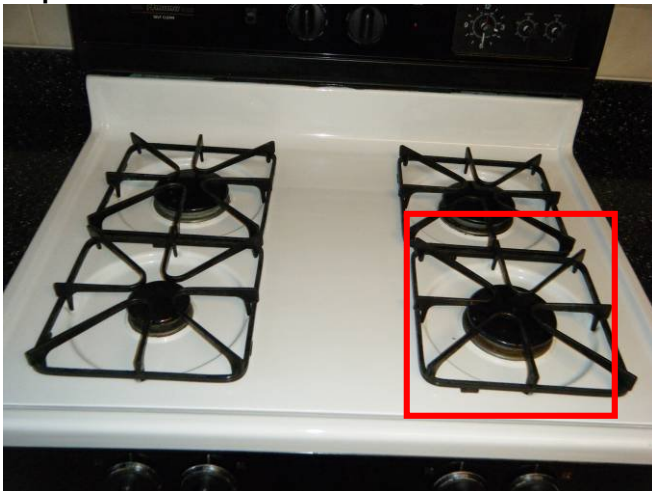
1. The right front burner igniter doesn't work and appears to be cracked.
2. While not required due to the age of the home, it is recommended that all countertop outlets be upgraded to provide GFCI protection.

30 Igniter doesn't work

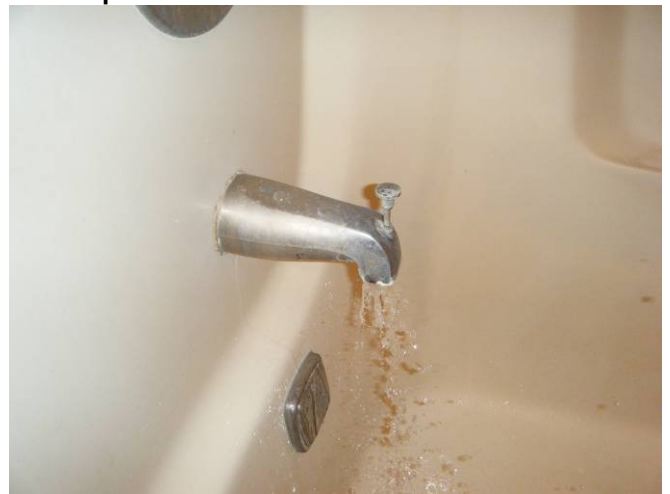
1. The tub spigot shower pull does not move due to corrosion. The spigot should be replaced.
2. The vanity top is cracked.

34 Master tub spigot corroded pull. Replace spigot

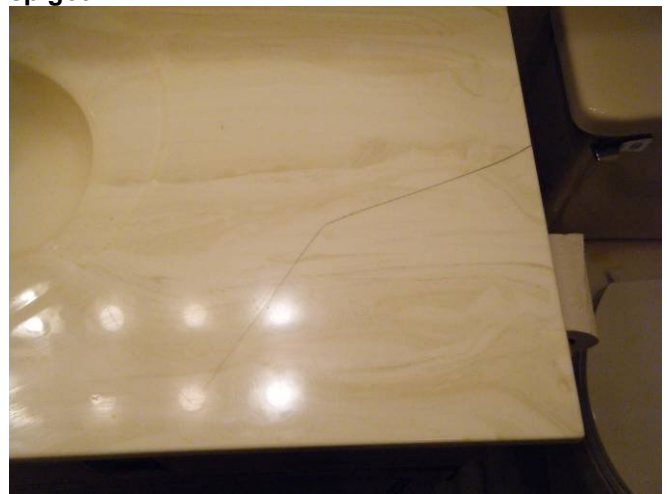
35 Crack in master vanity top

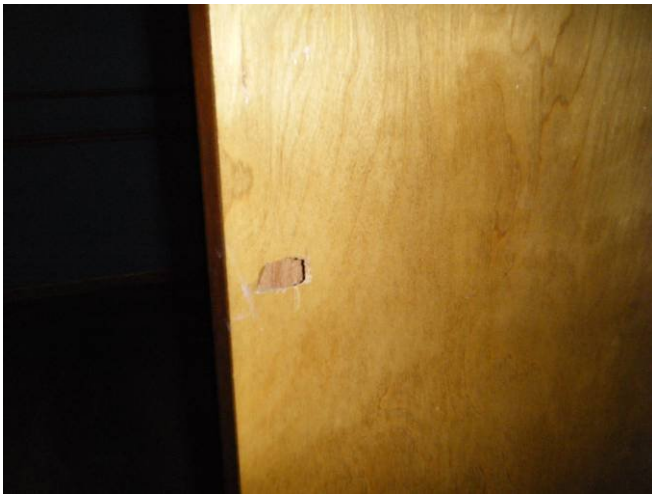
1. The entry door has a small hole in the back.

36 Hole in master bedroom door

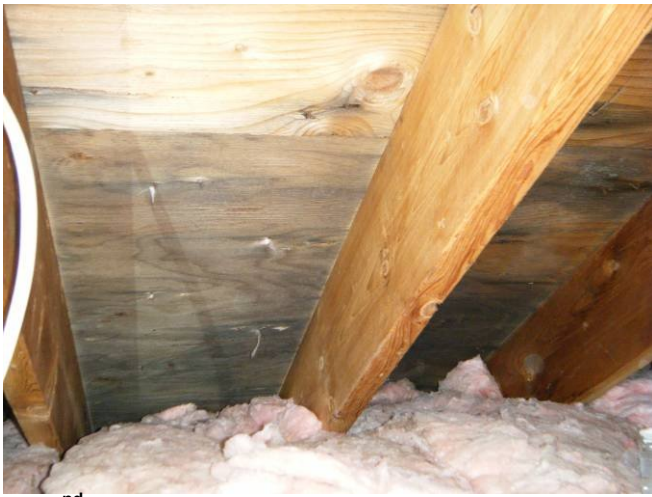
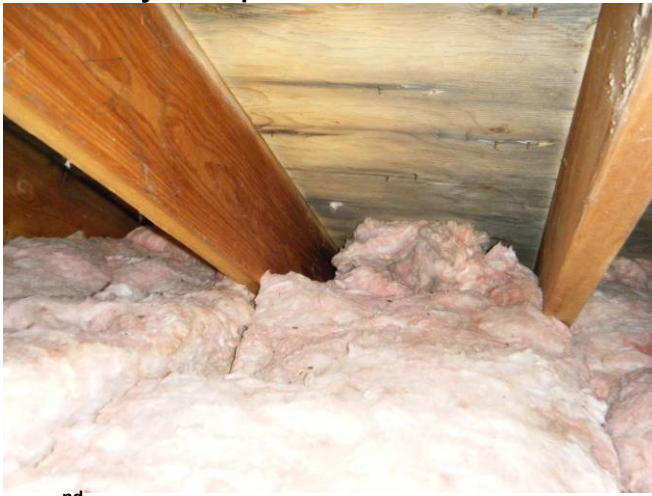
1. There is evidence of condensation throughout the attic as well as visible mold near the gutter line on the north side of the roof. I recommend further evaluation and remediation by a mold remediation contractor.
2. The bath vent fans discharge toward the soffit vents. These are small button vents and are undersized for this purpose. These should be directly vented to the exterior via insulated ducts. This and the whole house fan are the likely causes of the increased humidity / condensation in the attic.
3. The whole house fan should be sealed & insulated in the colder months.

42 2nd story attic space - mold

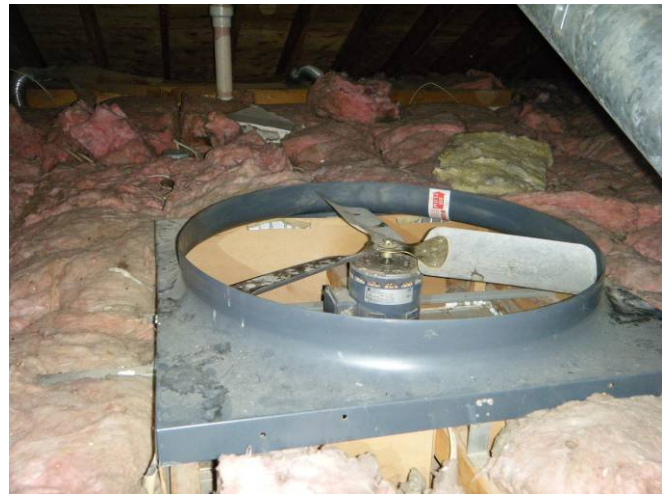
45 Seal and insulate fan in cold months

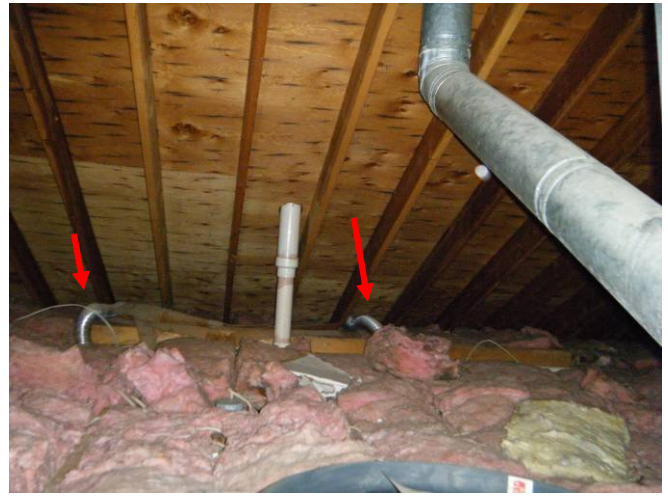
46 Bath vent fans to soffit vents

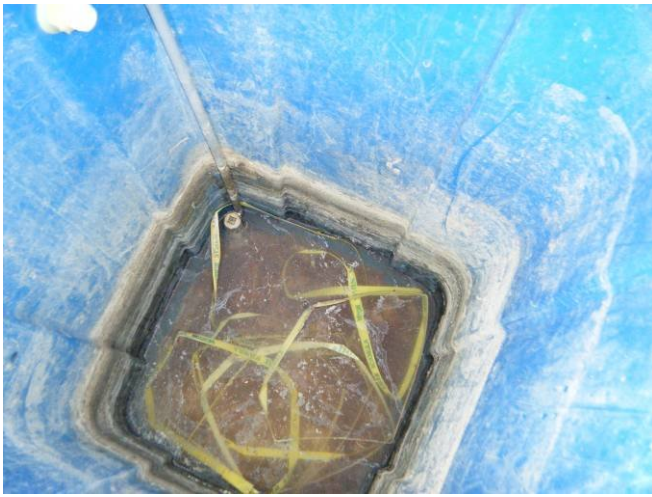
1. The sump pump was unplugged. Once plugged in it did not work. It should be replaced.
2. There is no evidence of any perimeter drain tile system - inside or outside.
3. There is a water softener present that does not appear to be in service.
4. A continuous vapor barrier that is sealed at all seams, to the walls and all penetrations is recommended.

54 Water softener not used

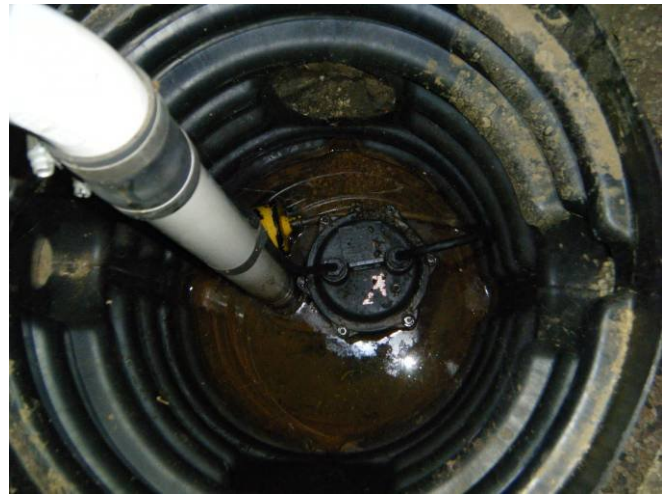
57 Sump pump doesn't work when plugged in

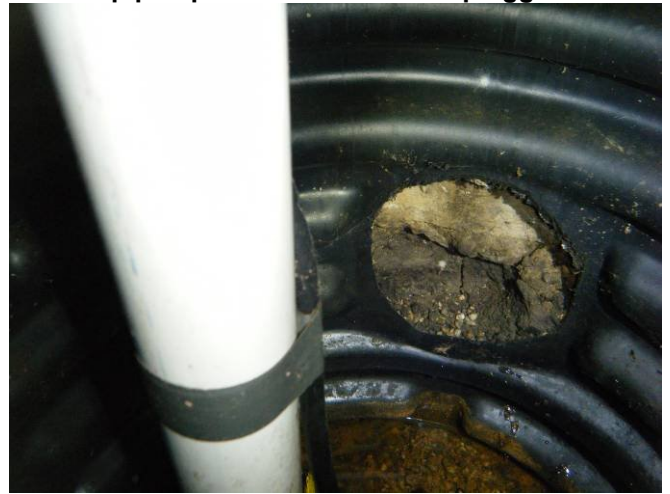
58 No drain tile system

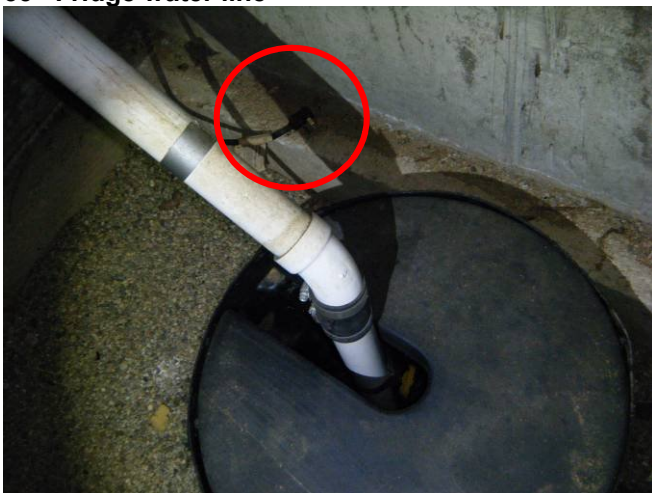
56 Sump not plugged in
