911 Home Inspection Services, LLC

Home Inspection Report

**205 N. Main Street
Anywhere, IL 66222**

Inspected on February 8, 2013

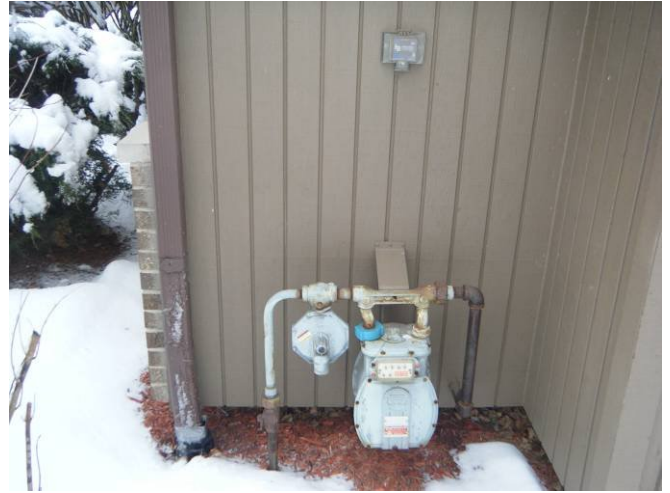
4 Gas meter & sending unit for water meter

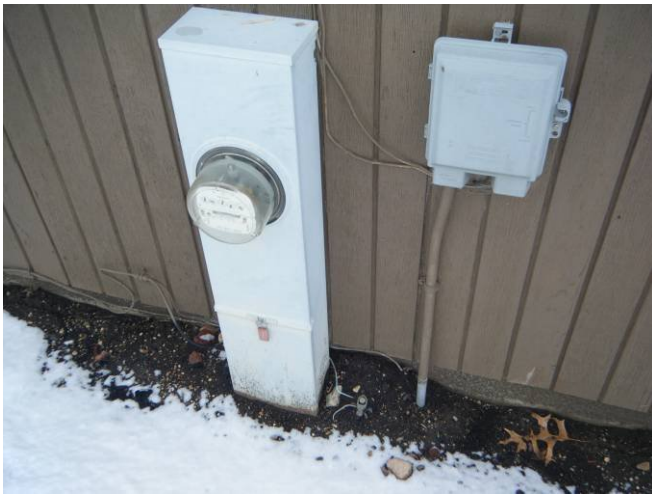
7 Electric & phone

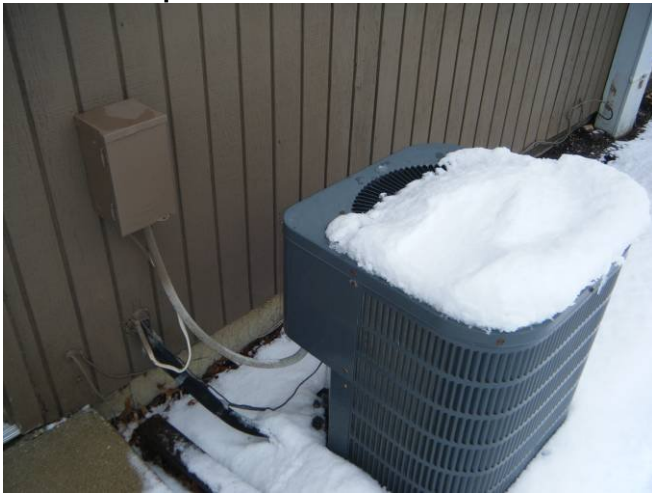
8 AC

5. The flue pipe should have 1-2" of clearance between itself and anything combustible. It is in direct contact with the drywall.
6. The air conditioner has a faded label that is hard to read. It may be a 1995. The AC was not able to be tested due to the outdoor air temperature being below 65°F. Operating an air conditioner below this temperature for an extended period of time can damage the unit.

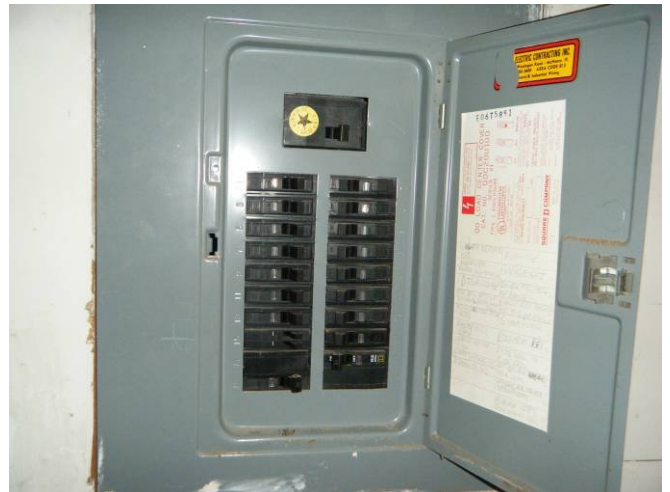
18 Main panel

1. In the main panel one breaker is triple tapped - three wires to one breaker. This is a fire hazard and should be corrected by a licensed electrician.

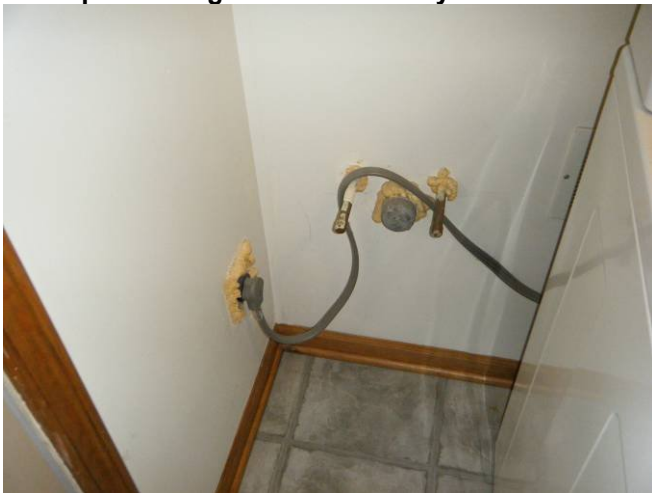
1. Lint is highly flammable. Clean the dryer vent when you first move in and at least annually thereafter.
2. The gas line should be capped to prevent a gas leak should the valve accidentally open or begin to leak.
3. If a utility sink is installed ensure the 220 volt dryer outlet is GFCI protected.

21 Utility sink hook-up

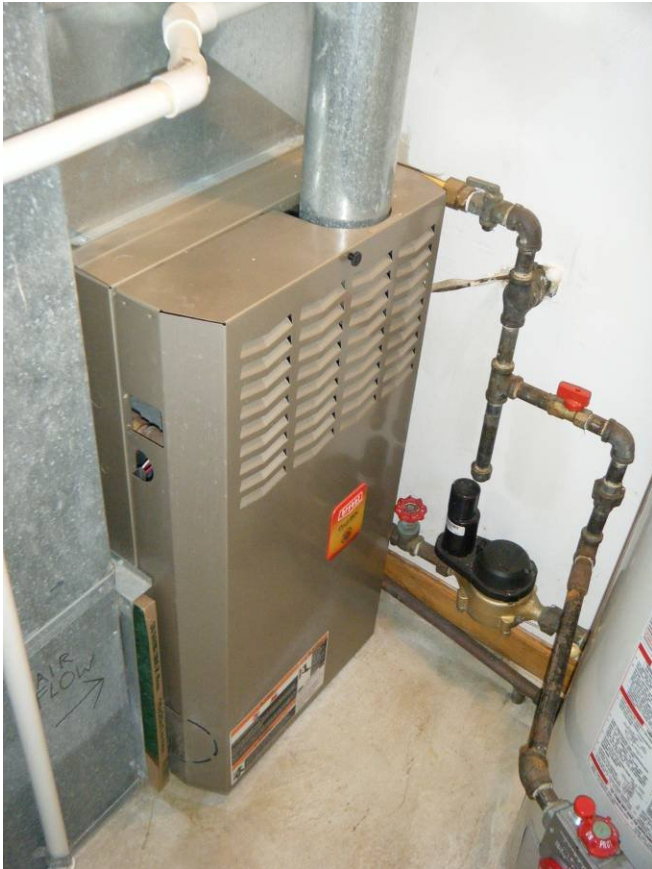
25 Furnace

1. The furnace is a 2003. It operated when tested; however, this was a brief test and only determined that it operated by the use of the thermostat. If the condition of the furnace is a concern I recommend it be serviced and/or evaluated by a certified HVAC technician prior to closing.

2. Keep in mind that only a certified HVAC technician can determine the integrity of the furnace heat exchanger. The heat exchanger separates combustion air from room air. A compromise of the heat exchanger generally means the furnace will need to be replaced.

3. There is a service sticker that indicates the furnace was last serviced on 11/15/11, the AC on 6/29/12 and the humidifier in 9/2012. Service is recommended at least every 2 years.

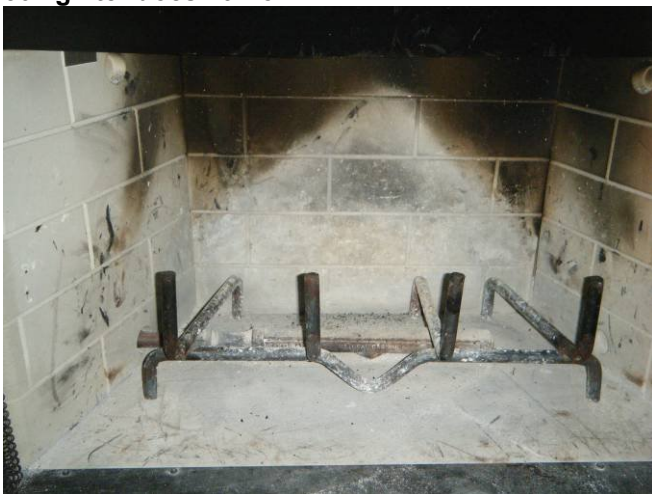
31 Fireplace

1. The fireplace flue has build-up and is due to be cleaned by a certified chimney sweep.
2. A wood burning grate is recommended. The current one is for gas logs.

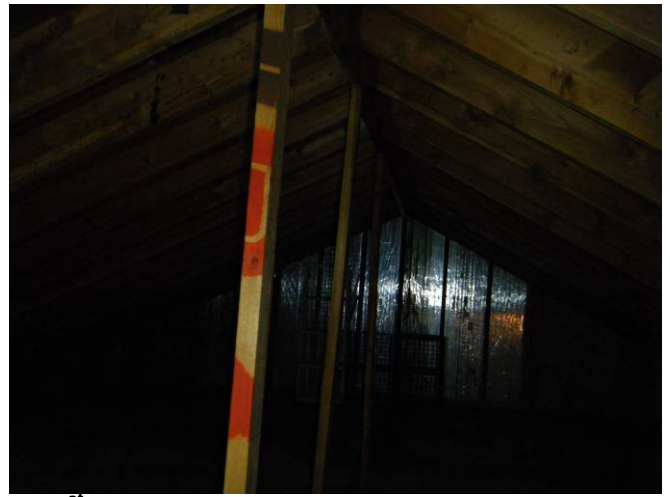
39 1st floor attic space

1. The soffit vents are small circular button vents. These are generally considered undersized and clog easily with insulation & debris. Consider installing larger vents. Use baffles to keep them from being covered with insulation.

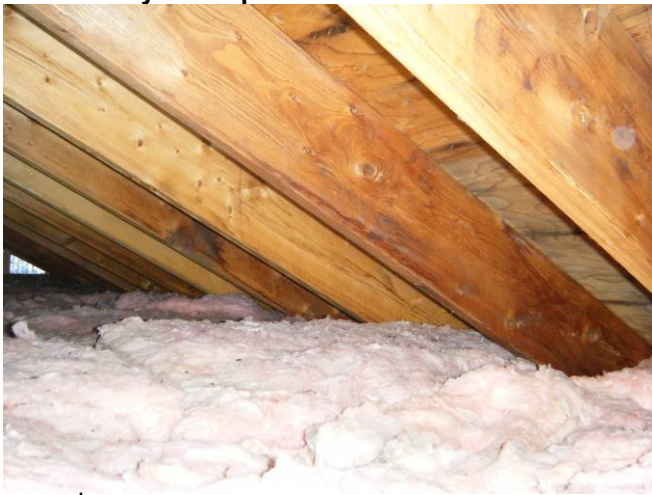
44 2nd story attic space

1. There is evidence of condensation throughout the attic as well as visible mold near the gutter line on the north side of the roof. I recommend further evaluation and remediation by a mold remediation contractor.
2. The bath vent fans discharge toward the soffit vents. These are small button vents and are undersized for this purpose. These should be directly vented to the exterior via insulated ducts. This and the whole house fan are the likely causes of the increased humidity / condensation in the attic.
3. The whole house fan should be sealed & insulated in the colder months.

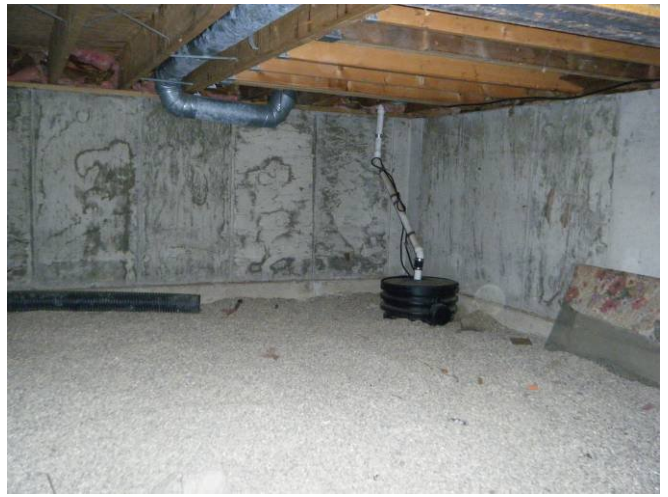
51 Crawl

1. The sump pump was unplugged. Once plugged in it did not work. It should be replaced.
2. There is no evidence of any perimeter drain tile system - inside or outside.
3. There is a water softener present that does not appear to be in service.
4. A continuous vapor barrier that is sealed at all seams, to the walls and all penetrations is recommended.

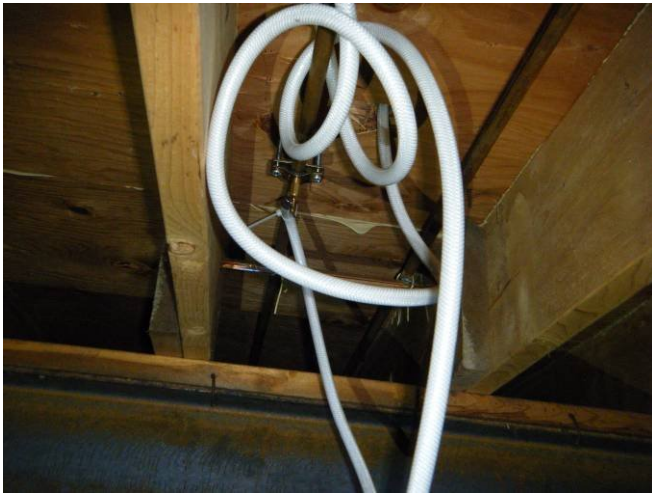
55 Fridge water line

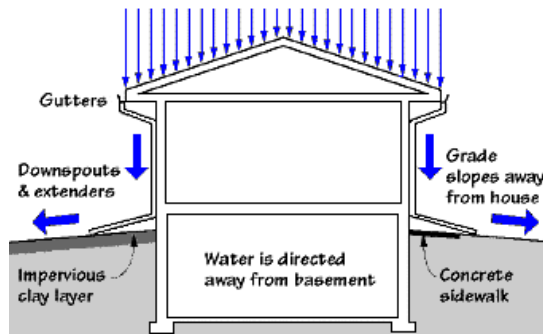
1. The driveway and walks were snow covered and not visible. If there is a patio it was snow covered as well.
2. The front stairs should have a railing since there are four or more risers.
3. The landscape grade around the foundation is essentially flat. It is desirable to have the landscape grade away from the foundation to shed rainwater.
4. Although not fully visible due to being snow covered, the three step landscape timber retaining wall has sections that are weathered / rotted and the walls are leaning.
